ARTC

SJ23-0631-RPT

**Euroa Goods Shed
Follow-up Inspection Report
13 February 2024**

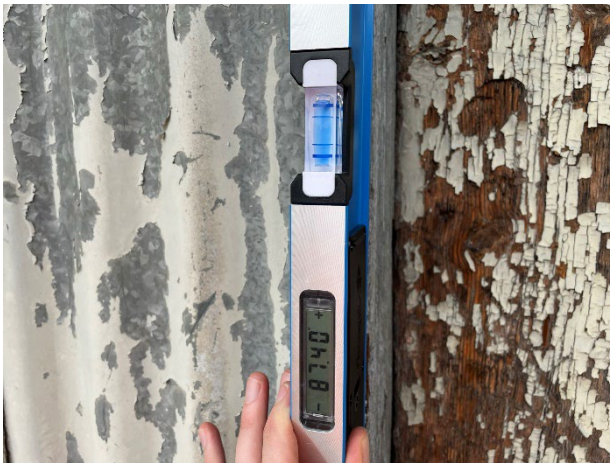
All 9No columns on the Up Side wall, and all 6No of the columns which could be safely accessed on the Down-Side wall were observed to be on a Down Side incline, of approximately 86°. This is an increase of 1° - 1.5° from the measurements taken during the previous inspection. Photos 1 and 2 show the difference in measurements across the 6-month period.

Photo: Previous incline at Downside wall (July 2023)

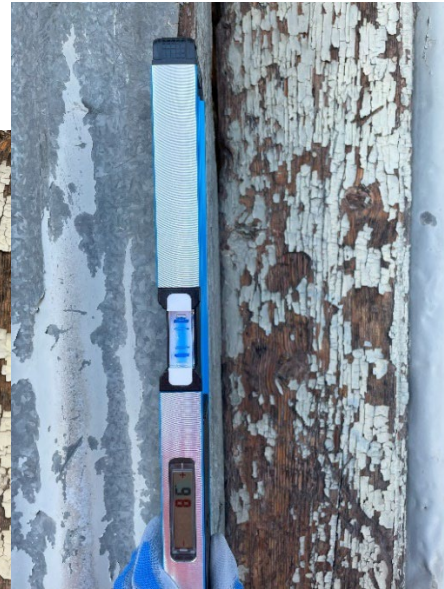
Photo 2: Current incline at Downside wall (Jan 2024)

The increase in structural lean of approximately 1.5 degrees over the 6-month period indicates a concerning rate of deterioration of the structure's lateral stability. This was highlighted in the initial report as a potential outcome due to ineffective connections between the frame and bluestone upstand, a lack of cross bracing in the transverse direction and rotting at the base of columns. The increased inward movement of the columns at the Up End is further indication of the structure's instability.

Demolition is recommended as soon as practically possible.

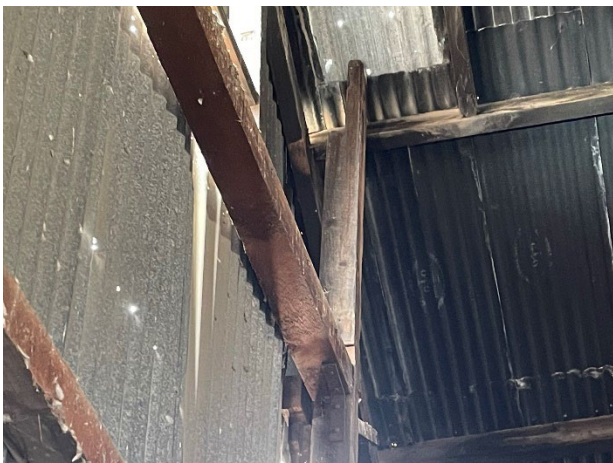
Previously, inspectors recorded the Up End timber column in Photo 3 as disconnected from the roof framework and leaning inwards. Exact measurements with a spirit level were unable to be taken due to safety concerns regarding the decking at this location. Photo 4 displays the increased lean recorded in the site revisit.

Whilst no measurement could be taken during either inspection, significant column movement is clear, as shown by the contrasting positions of the column relative to the roof sheeting corrugations.

Photo 3: Previous column lean at Upend wall

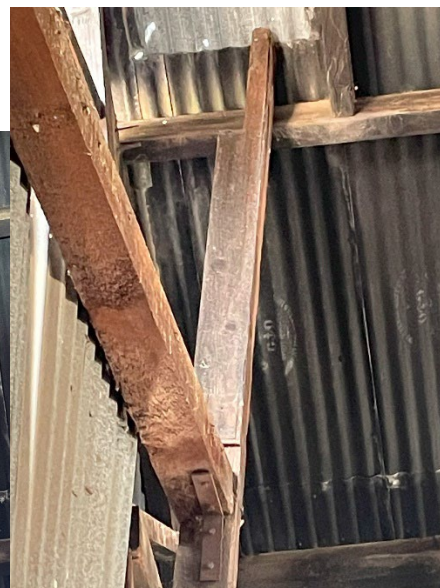
Photo 4: Current column lean at Upend wall

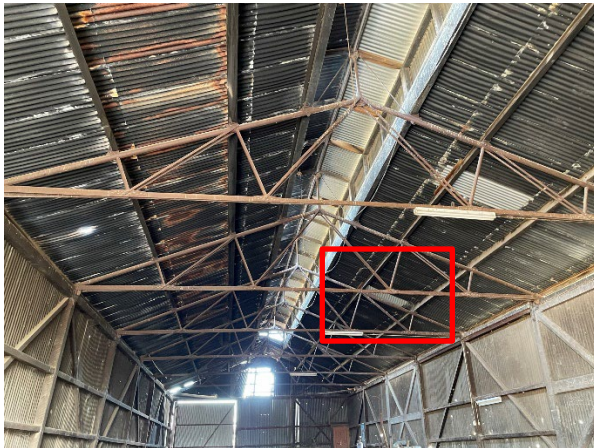
A section of roof sheeting which was observed during the initial inspection, was noted as missing during the follow-up inspection. From the movement of the sheeting and cladding observed during the inspection, and the presence of sheeting material observed on the ground adjacent The Shed we infer that the missing sheeting has been blown off in the wind.

Photo 5: Previous steel roof sheet present

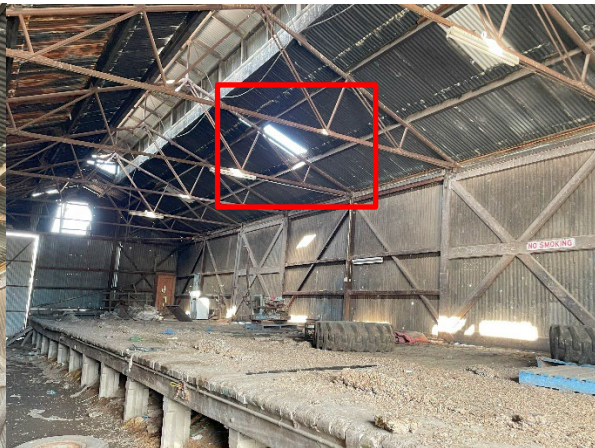
Other sheets were observed which are partially disconnected and could be seen moving under wind pressure during the site visit. Photos 5 and 6 show the location of the missing steel sheet.

Photo 6: Current steel roof sheet missing

It is considered likely that the missing steel roof sheeting has blown off and fallen onto the ground adjacent The Shed. This presents a serious falling-object hazard, as the structure is within close proximity to the train station and tracks. Roof sheeting and wall cladding were observed moving in the wind during the inspection, which indicates a potential for further disconnection of sheeting / cladding, and an ongoing risk of injury and / or property damage.

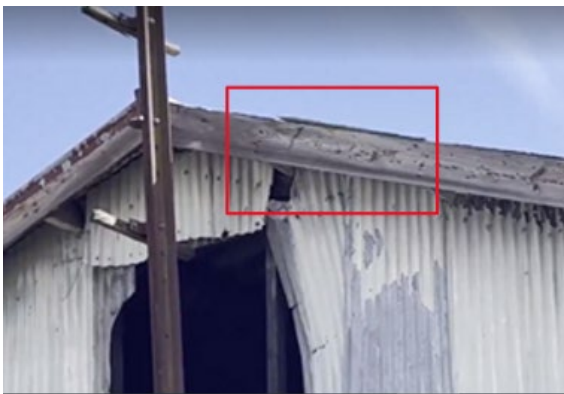
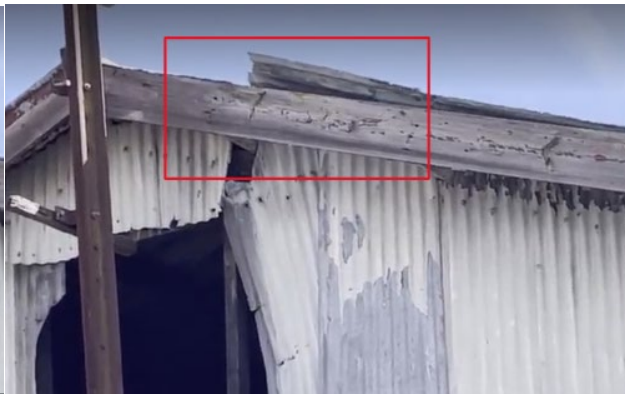
Photos 7 & 8, showing movement of roof sheeting during inspection

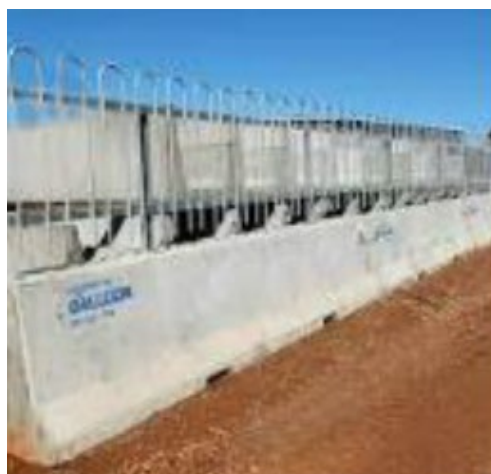
Photos 9, typical deflection screen which could be used between The Shed and the track to prevent impact near ground level

Note that to be most effective at reducing risk of falling roof sheeting or cladding from fouling the track or colliding with a train, the deflection screen would need to be taller than The Shed. Construction of a fence of this height would require structural and geotechnical design, and either props, tie backs, or cantilevered piles, all of which would increase the lead time to implementation of this mitigatory measure.

In order to reduce the risk of falling-cladding induced injury, the exclusion zone should be increased to extend to approximately 15m from the building line, which is calculated based on the height of the building plus a buffer zone.

We acknowledge that the track is located closer than this to The Shed, and therefore the exclusion zone fence at this location should be sufficiently robust to act as a protective barrier to deflect loose cladding away from the track.

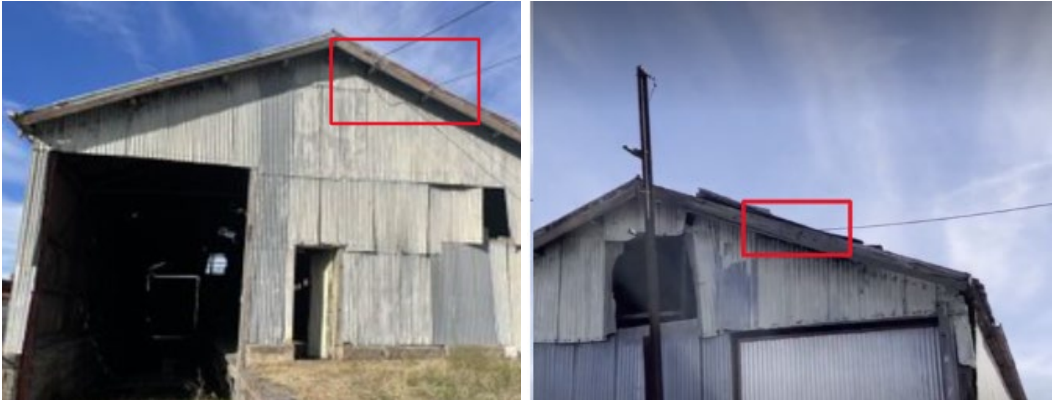
Photos 10A&10B, location of power lines connected to the northern and southern ends of The Shed (left to right)

The electrical wiring which is connected to the northern end of The Shed needs to be removed to prevent risk of electrocution and / or fire should The Shed collapse.
