SJ23-0631-RPT

**Benalla Signal Hut
Revisit Inspection Report**

25 April 2024

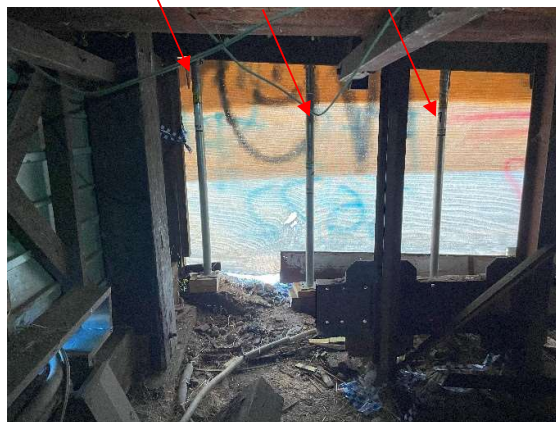
Impact damage on the northern wall had destroyed one of the columns and a number of surrounding timber wall studs, raising concern regarding the structural integrity of the building. Remediation works have since been undertaken which included the installation of multiple steel props to replace the destroyed column and wall studs, shown in Photo 1 below. Sterling did not confirm adequacy or provide advice regarding the steel props.

Photo 1: Steel Propping Installed

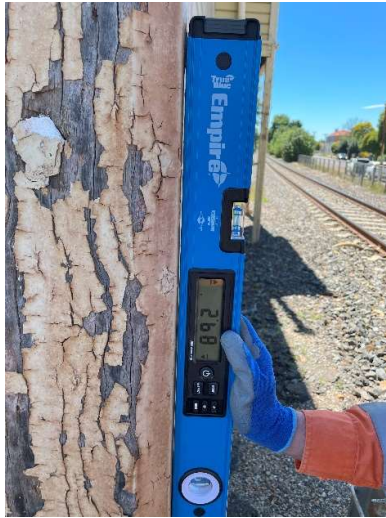
Previously, the northwest and southwest columns were both exhibiting signs of splitting and deterioration. Inspectors found no additional deterioration of the columns over the last 6 months.

Furthermore, the 8 No. steel columns supporting the staircase and 4 No. timber columns at each corner of the Hut were observed to be in the upright position, with no inclination recorded below 89.5°. The northwest and southwest can be observed in Photos 2 and 3.

Photo 2: Southwest Column

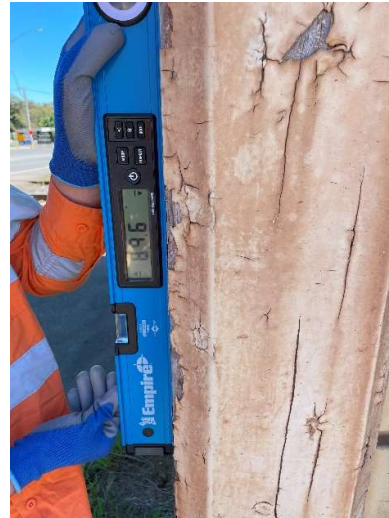
Photo 3: Northwest Column

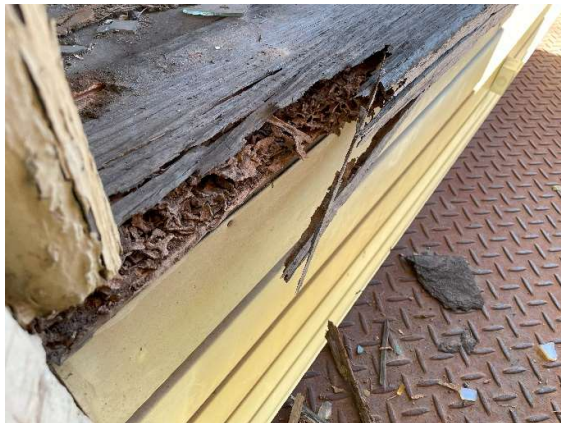
During the revisit, inspectors found the step into the upstairs level was severely rotted. On closer inspection, termites were found to be present in the timber. Photos 4 and 5 display the rotting and termites present in the timber.

Photo 4: Upstairs Step rotting

The termite decay observed necessitates termite treatment to reduce the rate of further decay. Access to the Hut must remain restricted due to the risk associated with termite-decayed timber. While termites were not found in primary structural members during this inspection, our previous report found potential evidence of termites in some structural columns.

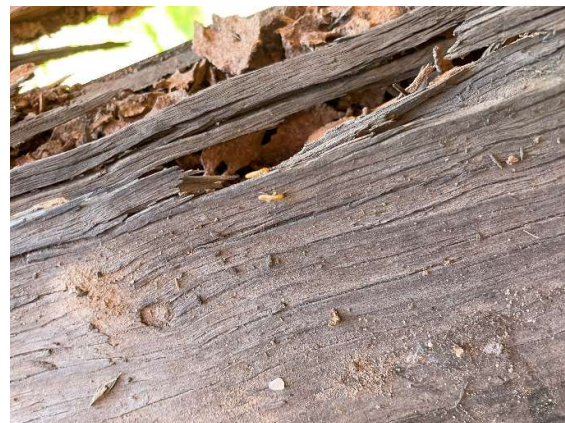
Photo 5: Termites present in timber
