INLAND RAIL PROJECT - NARRABRI TO NORTH STAR (N2NS)

SSI 7474 – 6 Monthly Construction Monitoring Report (November 2022 – April 2023)

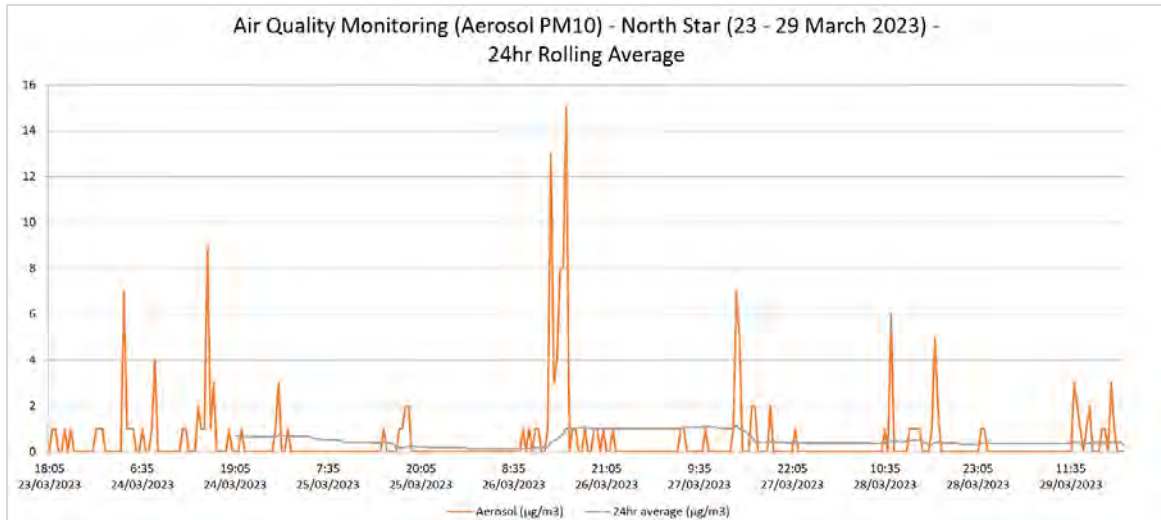
Attachment C1:

Pollutant	Averaging period	Criteria
PM10	24 Hours	50 µg/m ³

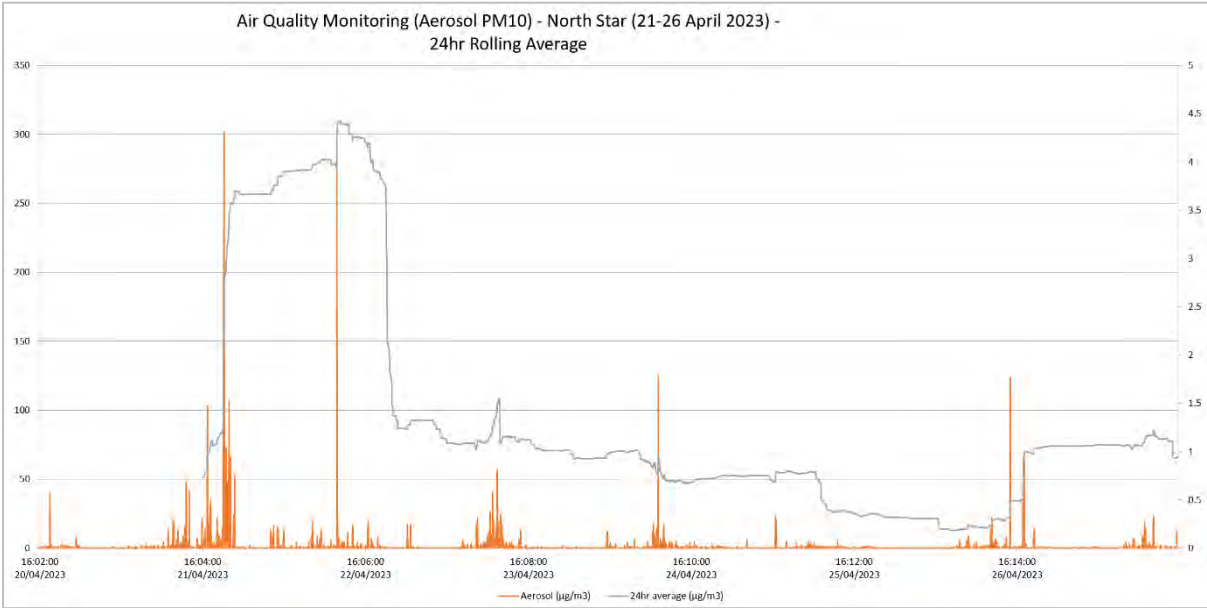
Attachment C3:

Pollutant	Averaging period	Criteria
PM10	24 Hours	50 µg/m ³

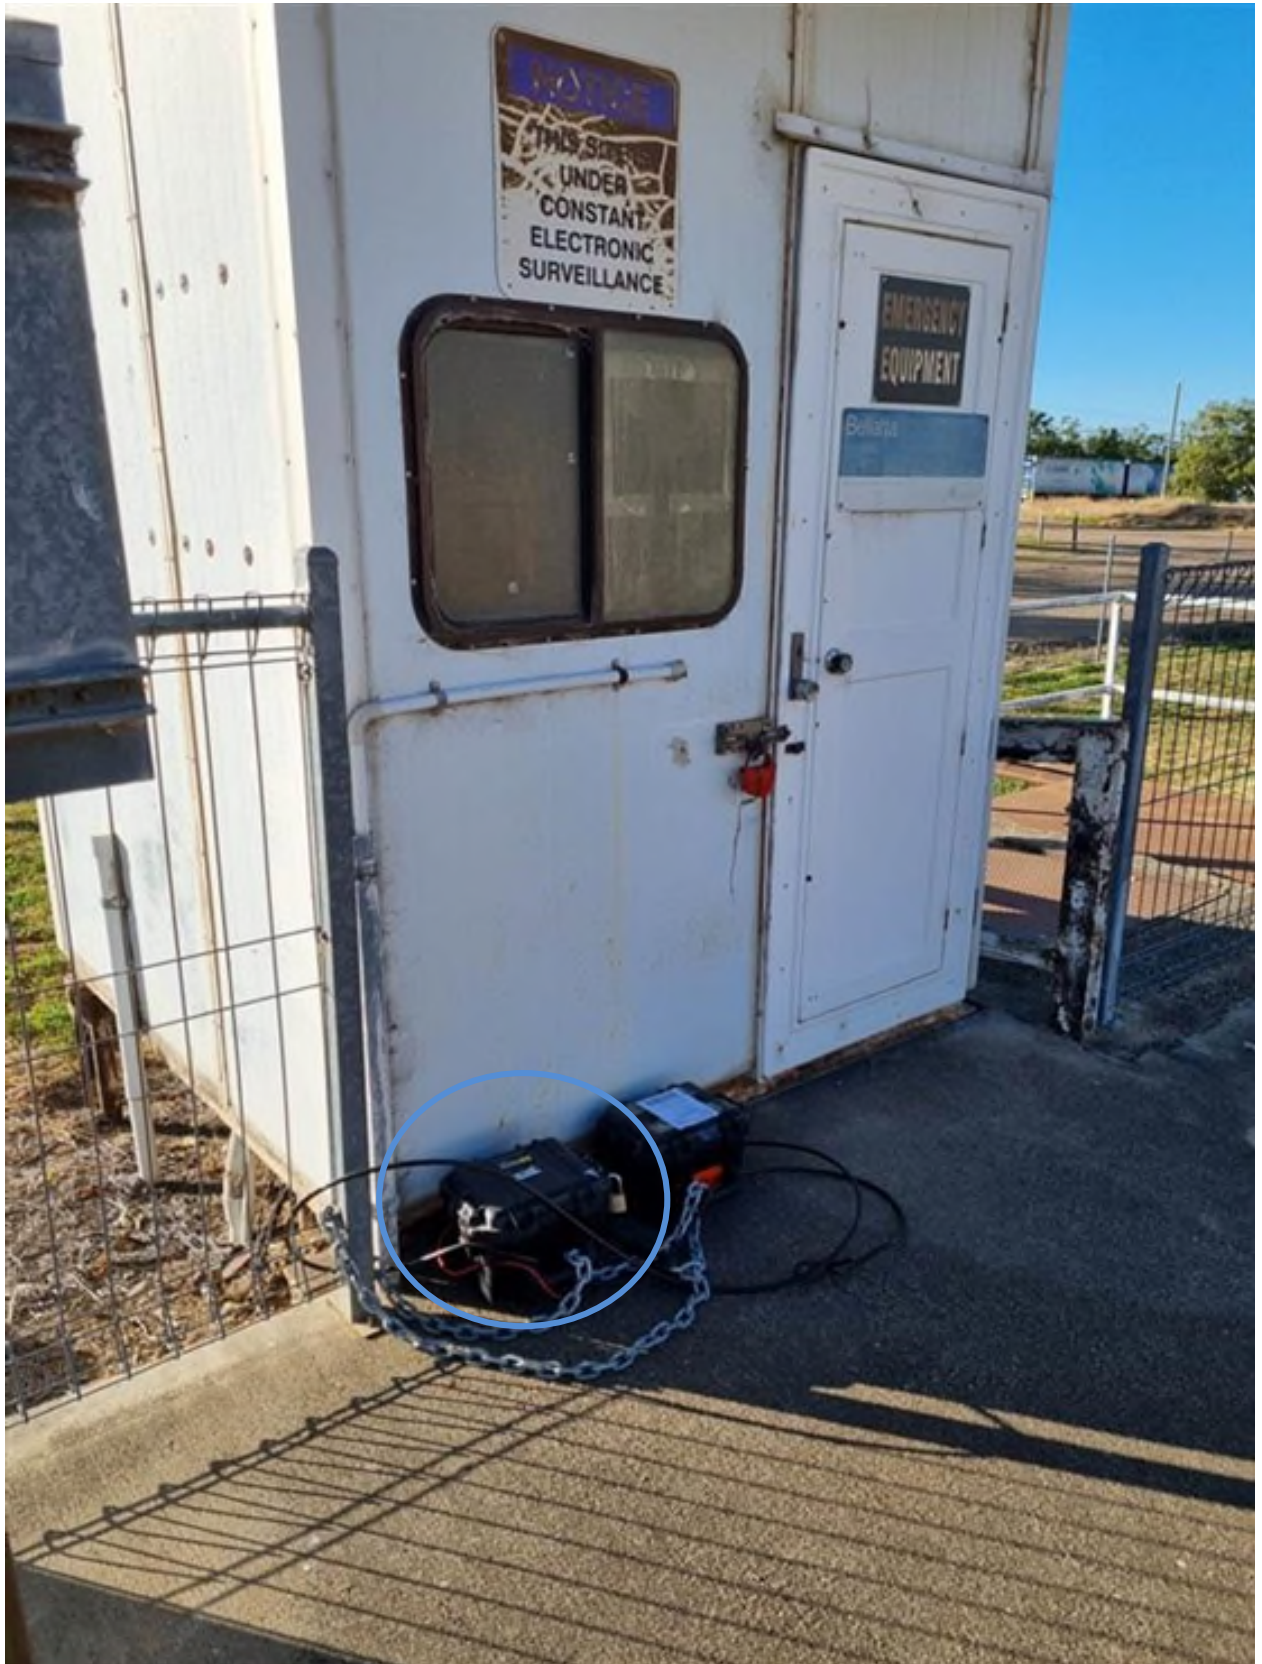
A.2 Bellata Station (Communication Building side) - Vibration monitoring location and equipment setup

Therefore, further vibration monitoring of the excavation works was not recommended. However, a vibration monitor was installed in front of the Communication building on the platform concrete slab to monitor for the duration of the construction works at the more sensitive receiver location on the platform. This monitor measured during the entire excavation works and future vibratory rolling works (managing vibration levels for both the station platform and the Communication building).
