Inland Rail - Beveridge to Albury, Phase 1, Tranche 2 Project (B2A)

IEA Six-Monthly Environmental Audit Report – May 2025

Document No: 5-0105-112-EEC-00-RP-0001
Revision: 0

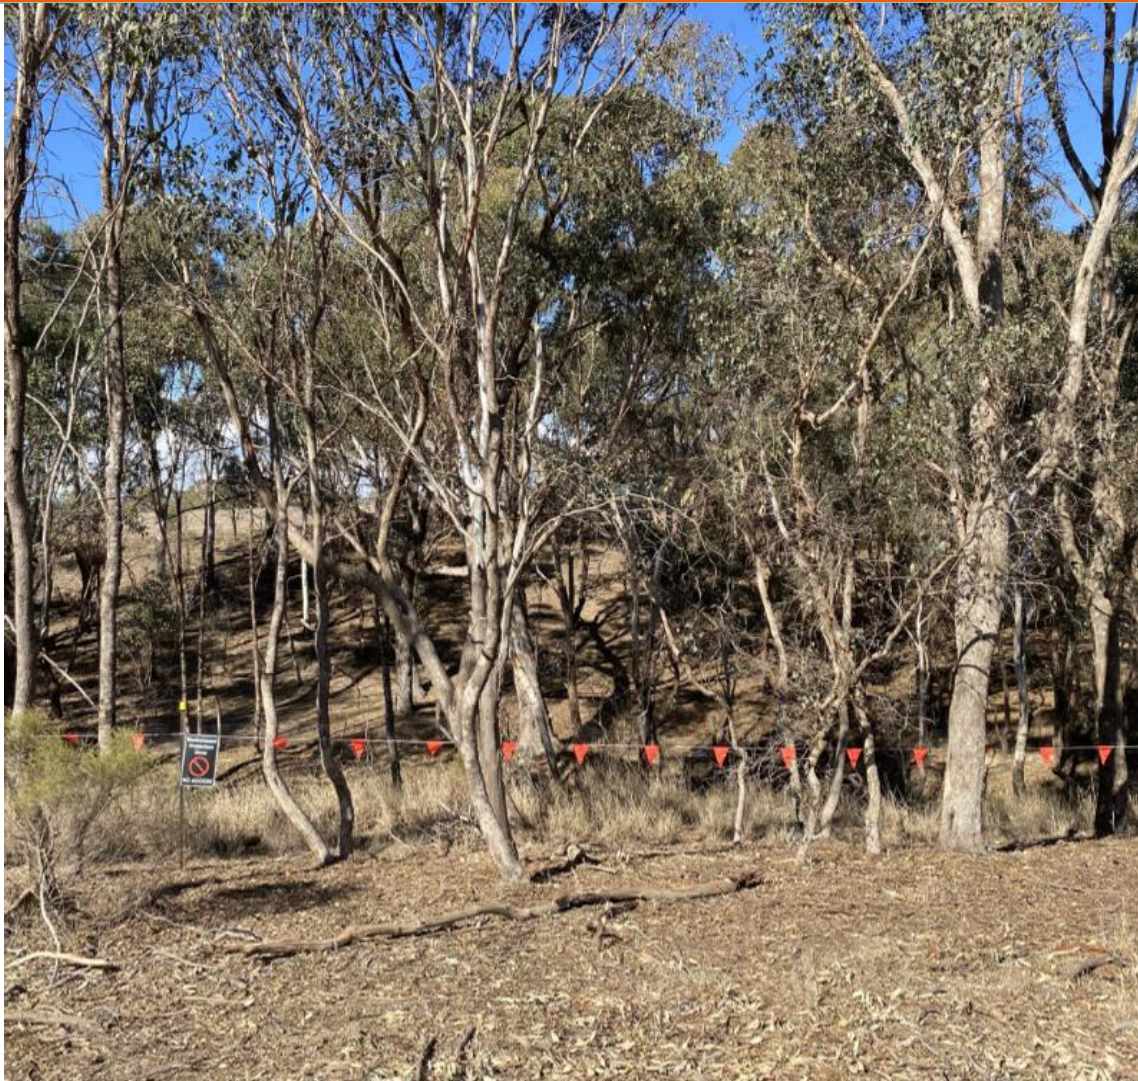
Item	Photo
<p>Photo 1_15-05-25_NGZ at Marchbanks</p>

<p>The photograph shows a dense stand of trees, likely eucalyptus, with light-colored bark and green foliage. In the foreground, there is a line of red flags strung across the area, and a small sign is visible on the left. The ground is covered with dry leaves and twigs.</p>
