**QUARTERLY
ENVIRONMENTAL
MONITORING REPORT -
JULY TO SEPTEMBER 2025**

**A2I | Albury to
Illabo**

6-0052-210-EEC-00-RP-1002

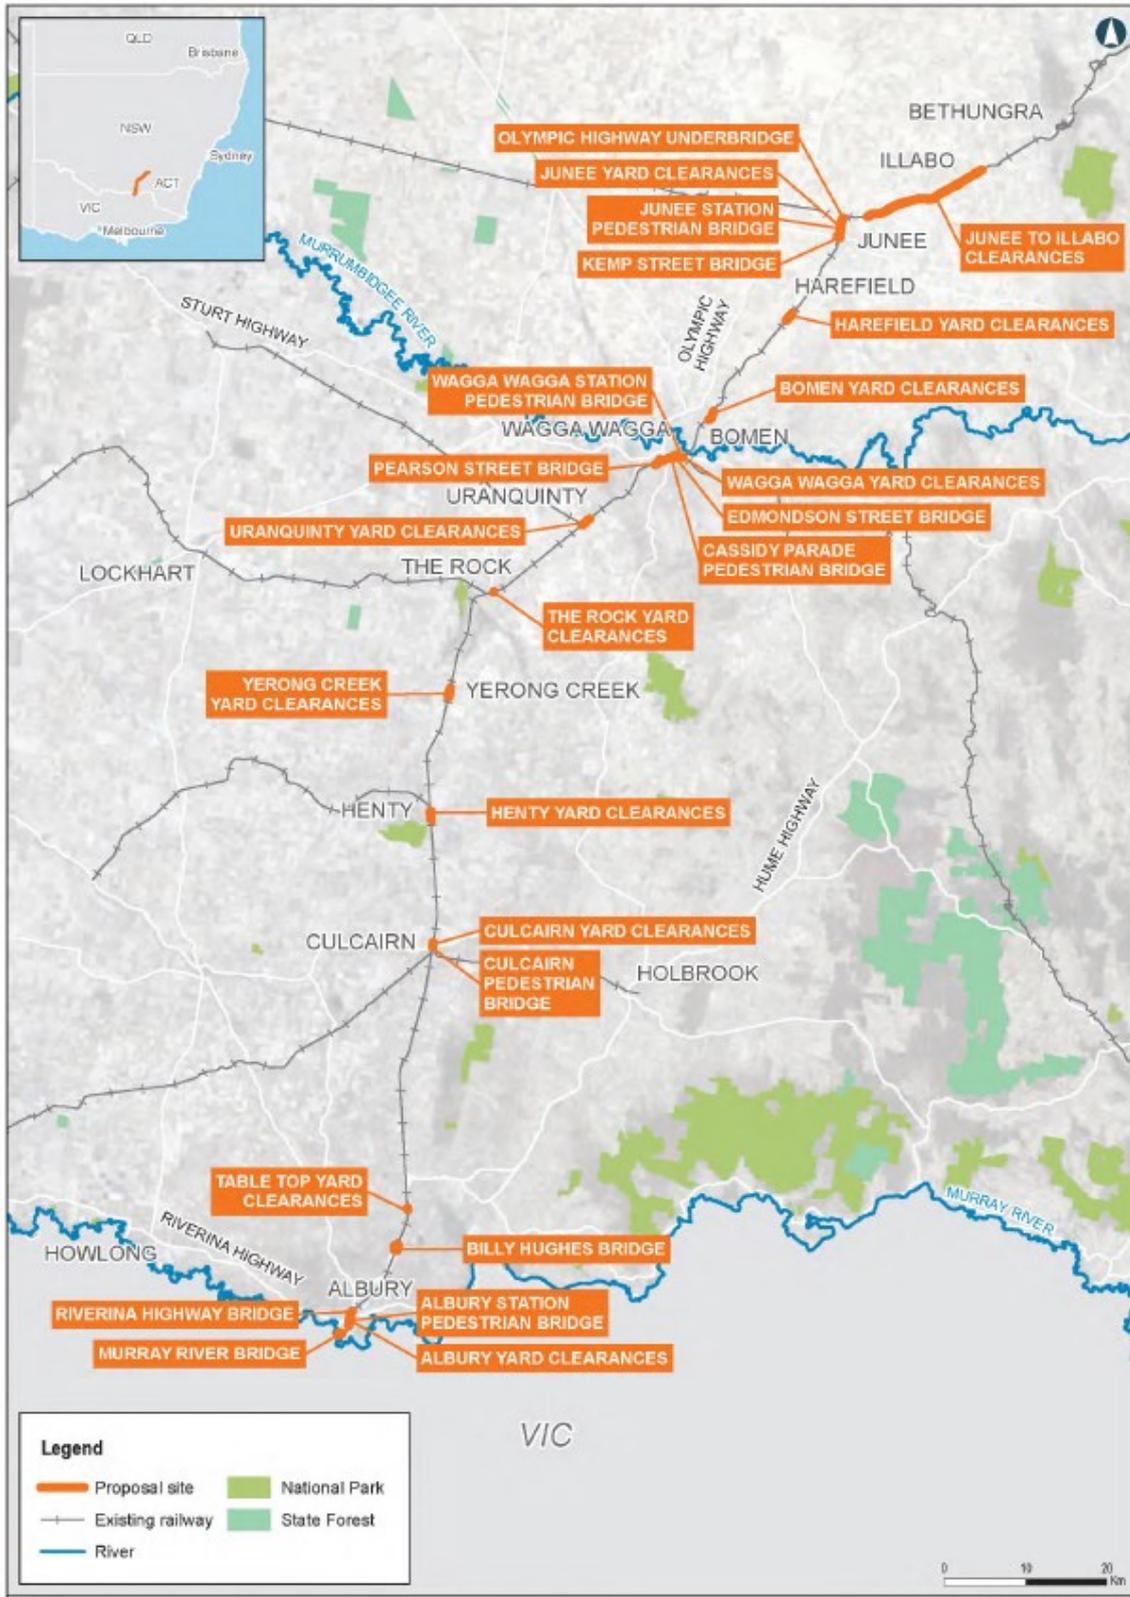
FIGURE 1: SITE OVERVIEW

The project will enable enhancement works to structures and sections of track along 185 km of the existing operational standard-gauge railway in the Albury to Illabo (A21) section of the Inland Rail program (refer to Figure 1). Enhancement works are required to provide the increased vertical and horizontal clearances required for double-stacked freight trains. Works would include track realignment, lowering and/or modification within the existing rail corridor, modification, removal or replacement of bridge structures (rail, road and/or pedestrian bridges), raising or replacing signal gantries, level-crossing modifications and other associated works

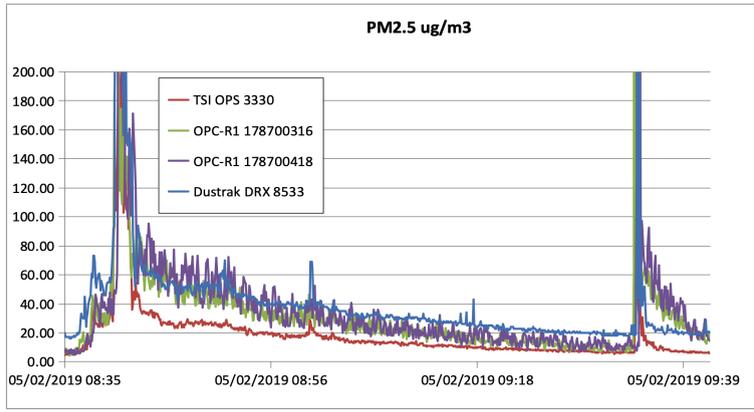
Comparison of PM2.5 monitoring by OPC-R2 sensor and TSI OPS 3330 and DustTrak instruments. All are set at 5s averaging and are sampling the ambient air of a workshop, the raw 3330 data has been used to calculate a PM figure.

Prior to deployment, the R2 is tested against TSI Optical Particle Sizer 3330 and DustTrak instruments.

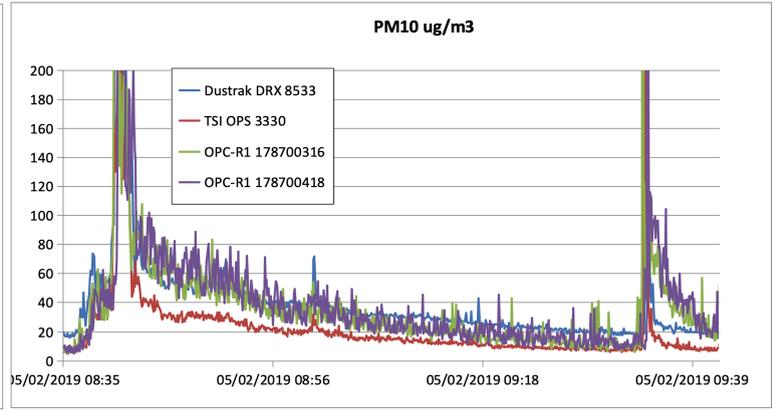
Comparison of PM10 monitoring by OPC-R2 sensor and TSI OPS 3330 and DustTrak instruments. All are set at 5s averaging and are sampling the ambient air of a workshop, the raw 3330 data has been used to calculate a PM figure.

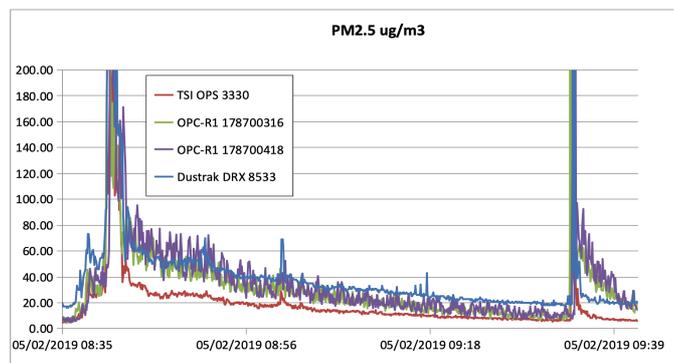
Comparison of PM2.5 monitoring by OPC-R2 sensor and TSI OPS 3330 and DustTrak instruments. All are set at 5s averaging and are sampling the ambient air of a workshop, the raw 3330 data has been used to calculate a PM figure.

Prior to deployment, the R2 is tested against [TSI Optical Particle Sizer 3330](#) and [DustTrak instruments](#).

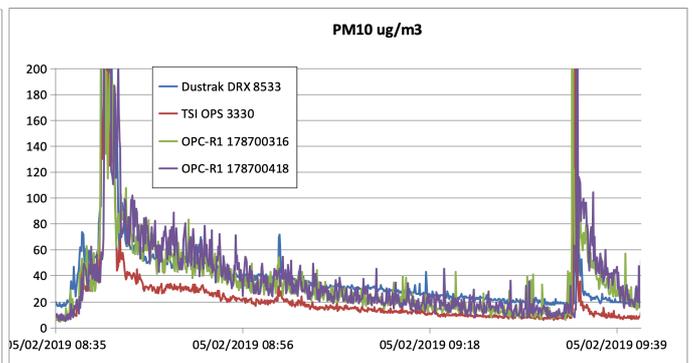
Comparison of PM10 monitoring by OPC-R2 sensor and TSI OPS 3330 and DustTrak instruments. All are set at 5s averaging and are sampling the ambient air of a workshop, the raw 3330 data has been used to calculate a PM figure.

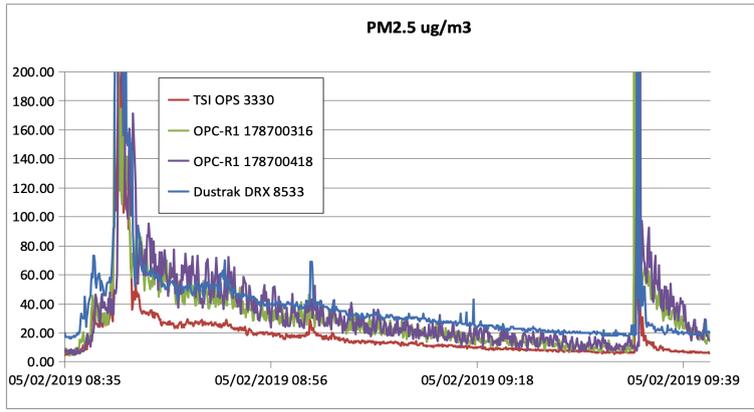
Comparison of PM2.5 monitoring by OPC-R2 sensor and TSI OPS 3330 and DustTrak instruments. All are set at 5s averaging and are sampling the ambient air of a workshop, the raw 3330 data has been used to calculate a PM figure.

Prior to deployment, the R2 is tested against TSI Optical Particle Sizer 3330 and DustTrak instruments.

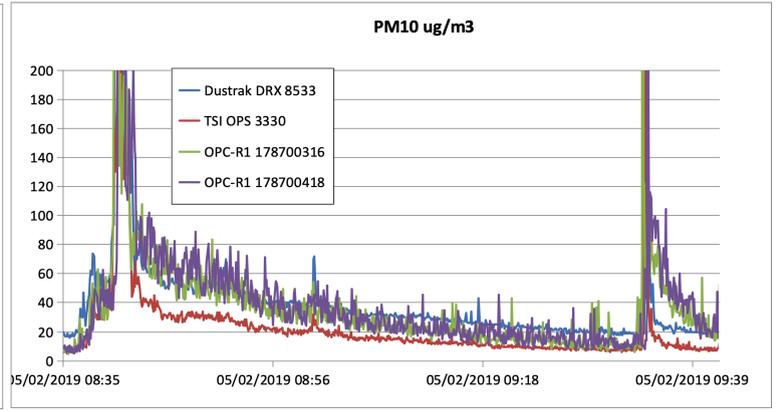
Comparison of PM10 monitoring by OPC-R2 sensor and TSI OPS 3330 and DustTrak instruments. All are set at 5s averaging and are sampling the ambient air of a workshop, the raw 3330 data has been used to calculate a PM figure.

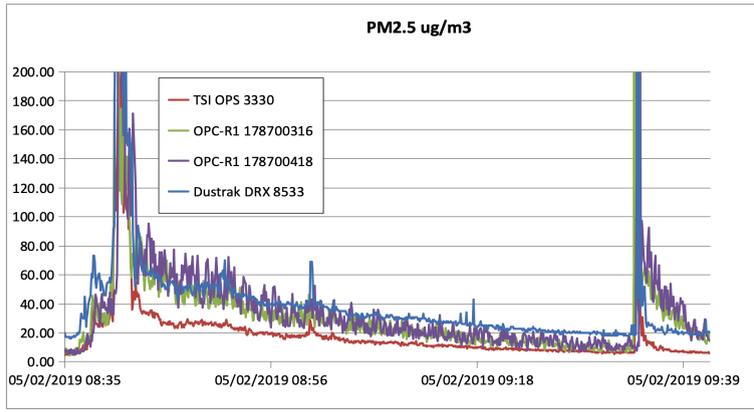
Comparison of PM2.5 monitoring by OPC-R2 sensor and TSI OPS 3330 and DustTrak instruments. All are set at 5s averaging and are sampling the ambient air of a workshop, the raw 3330 data has been used to calculate a PM figure.

Prior to deployment, the R2 is tested against TSI Optical Particle Sizer 3330 and DustTrak instruments.

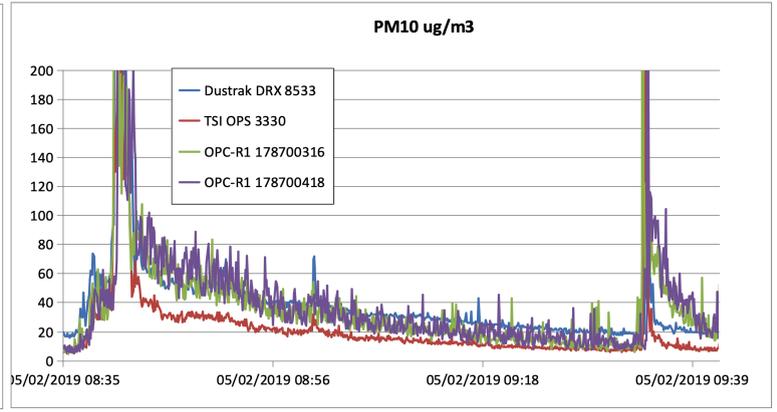
Comparison of PM10 monitoring by OPC-R2 sensor and TSI OPS 3330 and DustTrak instruments. All are set at 5s averaging and are sampling the ambient air of a workshop, the raw 3330 data has been used to calculate a PM figure.

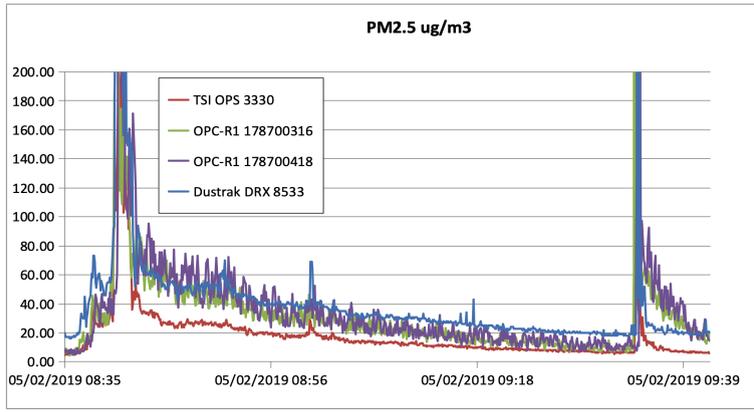
Comparison of PM2.5 monitoring by OPC-R2 sensor and TSI OPS 3330 and DustTrak instruments. All are set at 5s averaging and are sampling the ambient air of a workshop, the raw 3330 data has been used to calculate a PM figure.

Prior to deployment, the R2 is tested against TSI Optical Particle Sizer 3330 and DustTrak instruments.

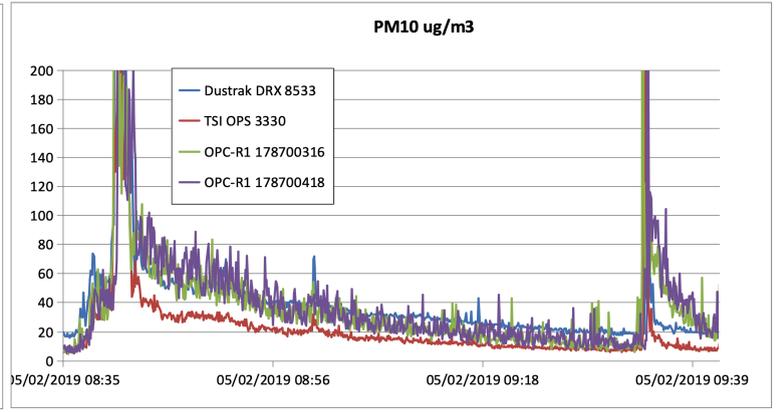
Comparison of PM10 monitoring by OPC-R2 sensor and TSI OPS 3330 and DustTrak instruments. All are set at 5s averaging and are sampling the ambient air of a workshop, the raw 3330 data has been used to calculate a PM figure.
