# INLAND RAIL

## ILLABO TO STOCKINBINGAL PROJECT

### I2S | Construction Environmental Monitoring Report

Document Number: 6-0019-220-EEC-00-RP-0009

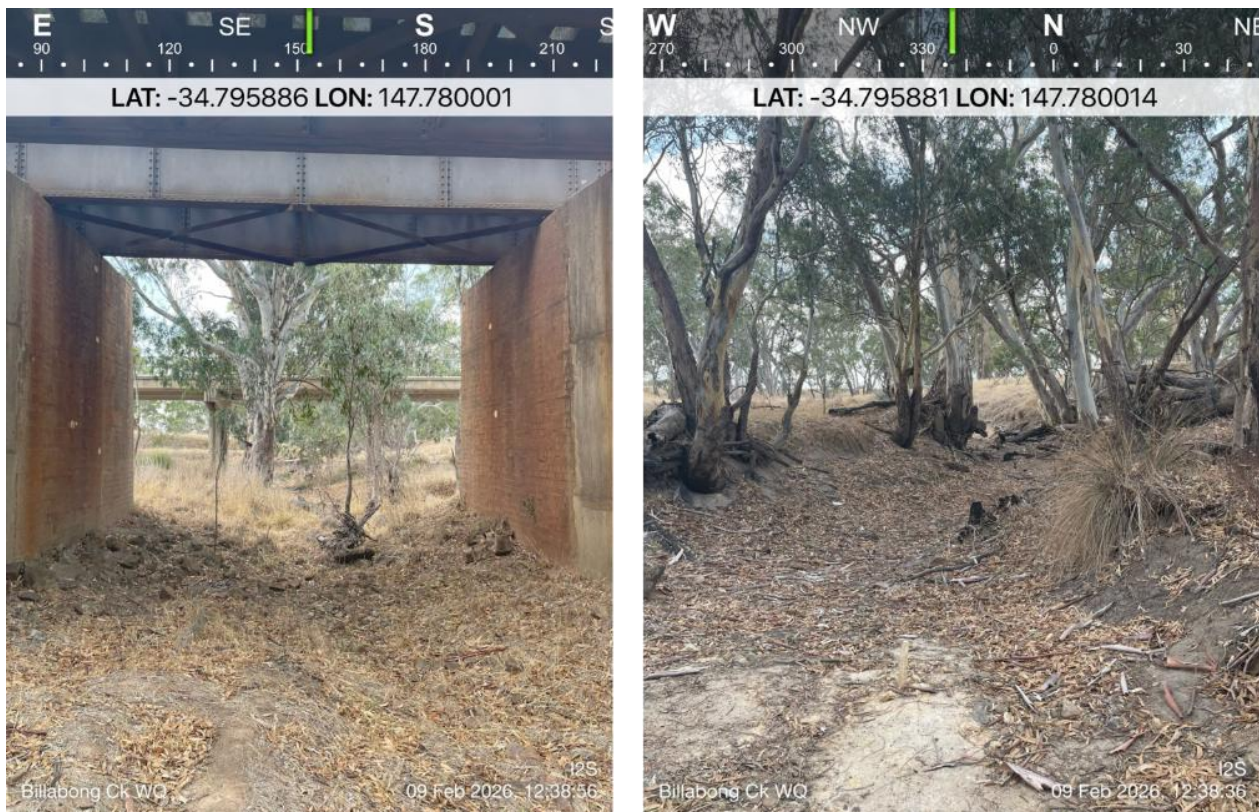
Figure B-1 Downstream and upstream (respectively) at Billabong Creek – February 2026

During the reporting period, and throughout routine site inspections, no flowing conditions were observed at the monitoring location. Observations generally recorded dry creek bed conditions with isolated areas of ponding present following rainfall events. Representative photographs of the upstream and downstream monitoring locations are provided below to document prevailing site conditions and seasonal changes observed at Billabong Creek.

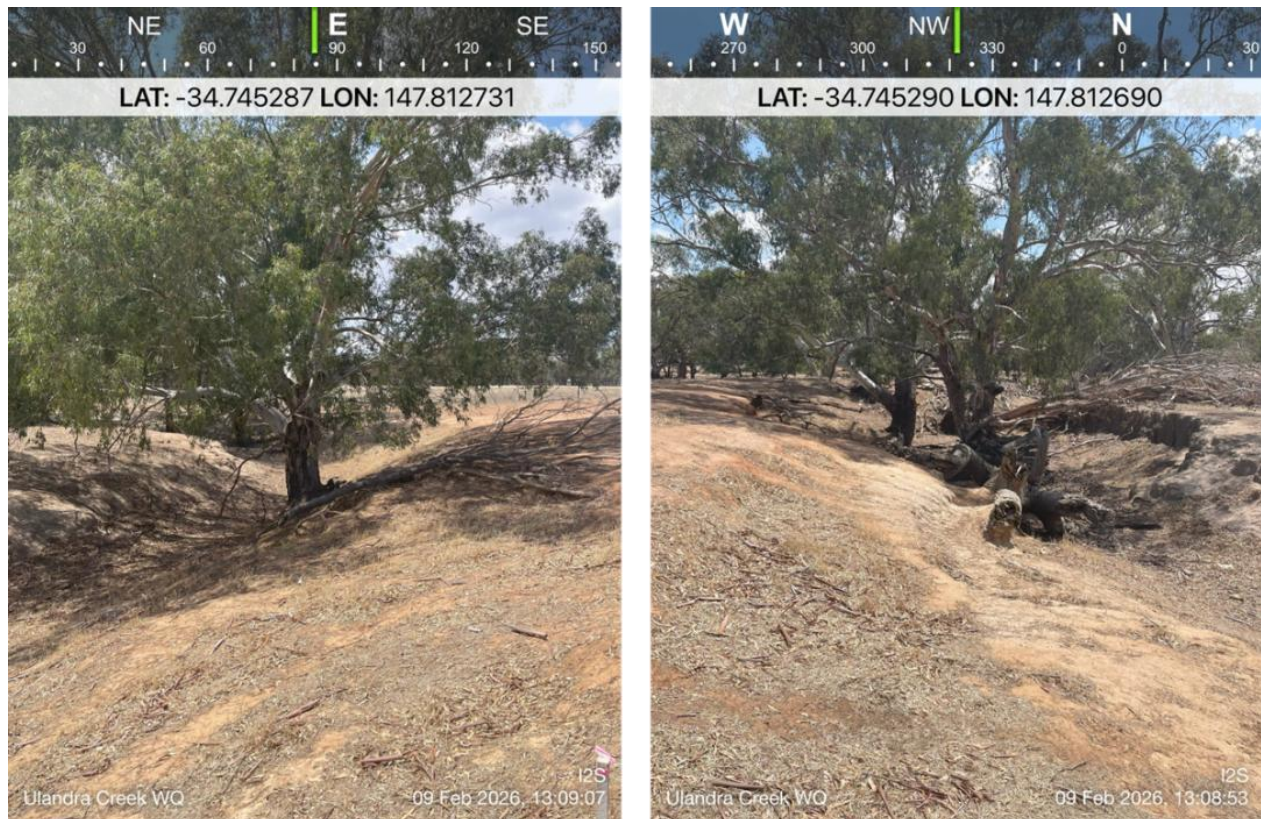
Figure B-5 Downstream and upstream (respectively) at Ulandra Creek – February 2026

Ulandra Creek is a 5<sup>th</sup> order ephemeral watercourse within the Murrumbidgee River catchment and is intersected by the Project at CH7900 in construction section 2. The creek generally flows from east to west and converges with Ironbong Creek downstream of the Project area. During the reporting period, and throughout routine site inspections, no flowing conditions were observed at the monitoring location. Observations generally recorded dry creek bed conditions. Representative photographs of the upstream and downstream monitoring locations are provided below to document prevailing site conditions and seasonal changes observed at Ulandra Creek.

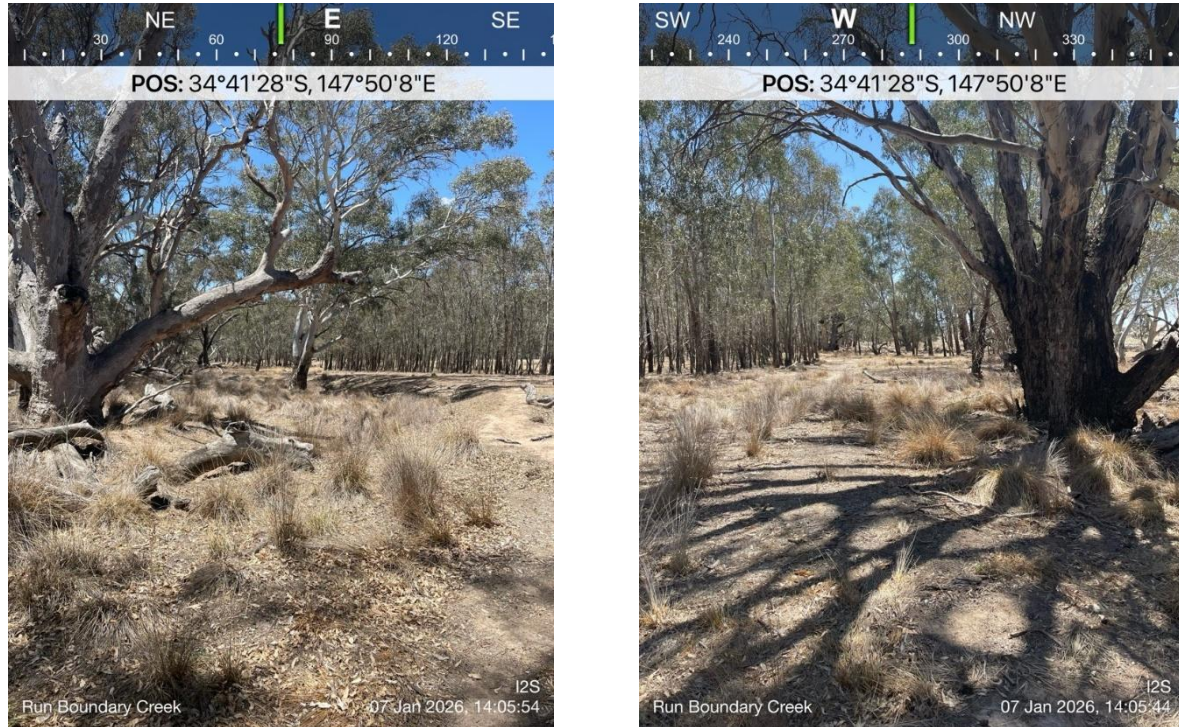
Figure B-9 Downstream and upstream (respectively) at Run Boundary Creek – January 2026

Run Boundary Creek is a 3<sup>rd</sup> order ephemeral watercourse within the Murrumbidgee River catchment and is intersected by the Project at CH14320 in construction section 3. The creek generally flows in a north-westerly direction before turning south-east and converging with Ironbong Creek downstream of the Project area. During the reporting period, the monitoring location remained dry, and no surface water was present during any monitoring inspection.

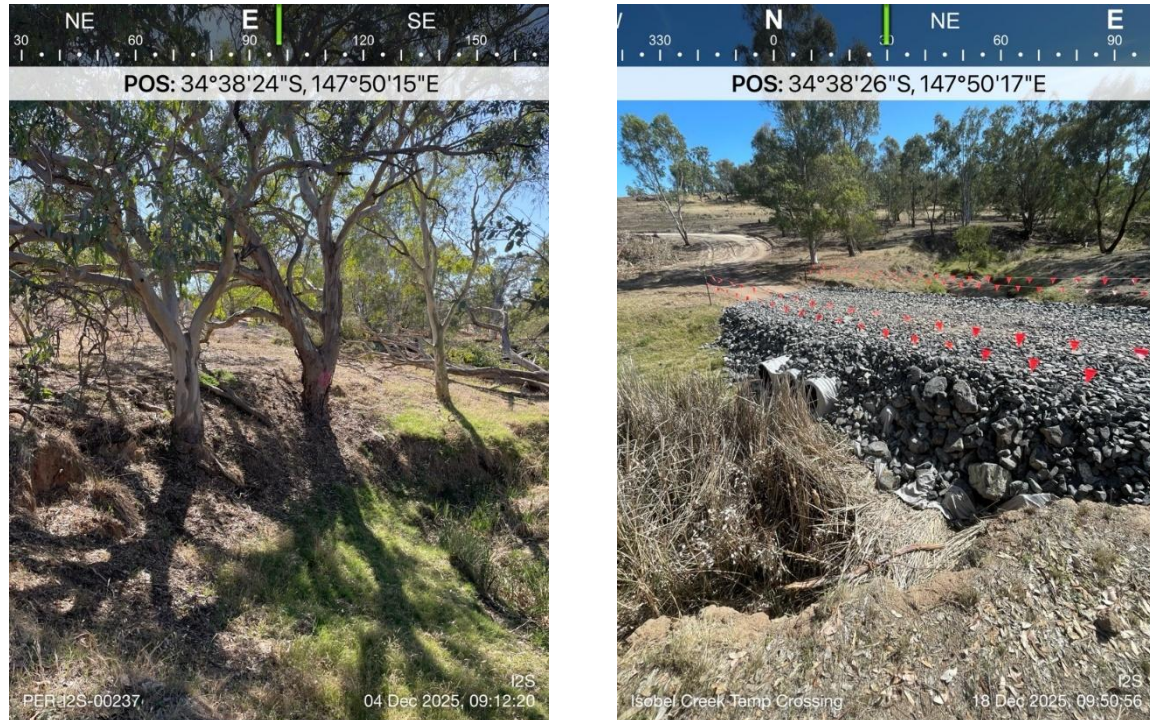
Figure B-14 Downstream and upstream (respectively) at Isobel Creek – December 2025

Monitoring inspections undertaken during the reporting period consistently recorded dry channel conditions, with no observable surface water present at the monitoring location. Representative photographs of the upstream and downstream monitoring locations are provided below to document prevailing site conditions throughout the reporting period.

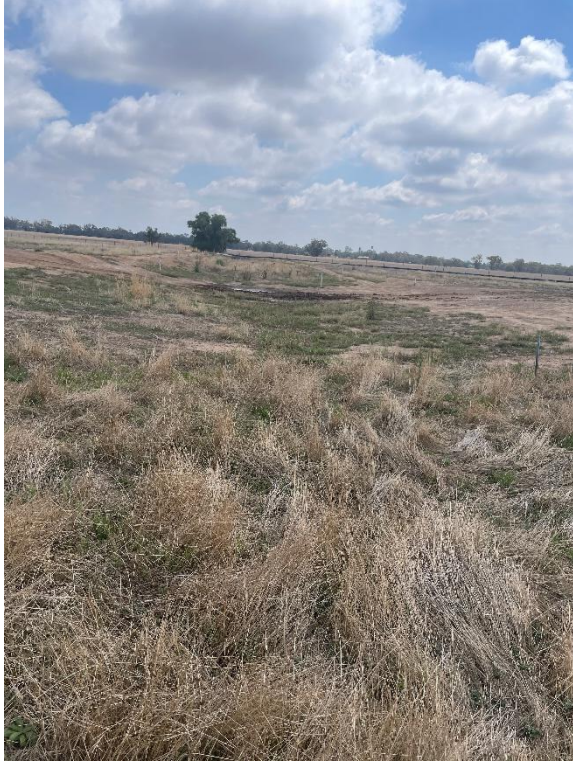
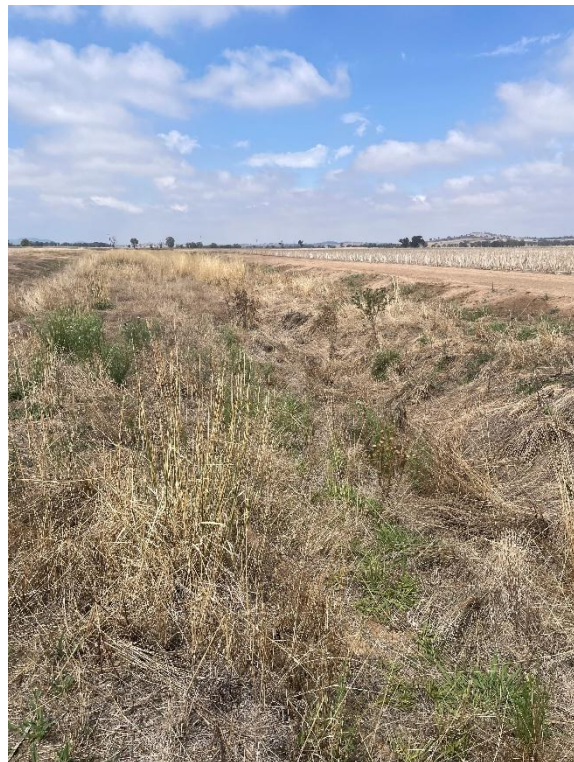
Figure B-18 Downstream and upstream (respectively) at Powder Horn Creek – February 2026

Powder Horn Creek is a 3<sup>rd</sup> order ephemeral watercourse within the Lachlan River catchment and is intersected by the Project at CH35900 in construction section 5. The creek generally flows from south to north before joining Bland Creek downstream. Throughout the reporting period, the monitoring location remained dry, with no observable surface water or flow events recorded during routine inspections. Representative photographs of the upstream and downstream monitoring locations are provided below.

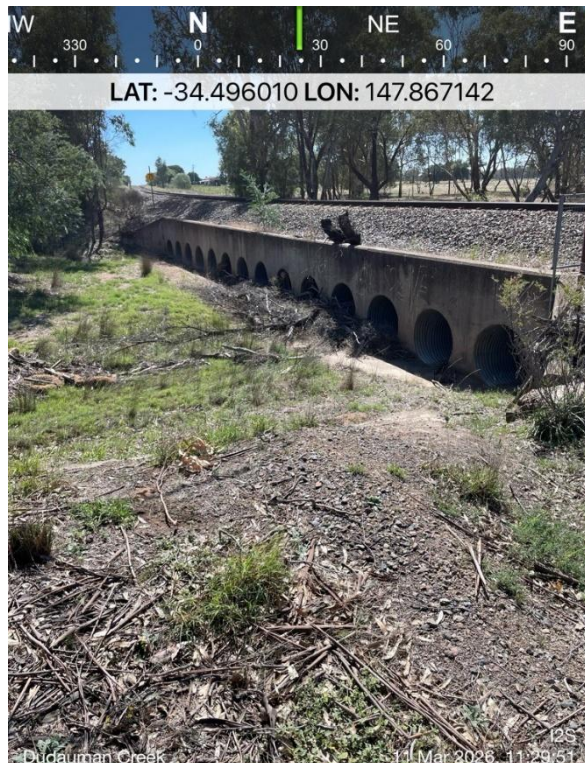
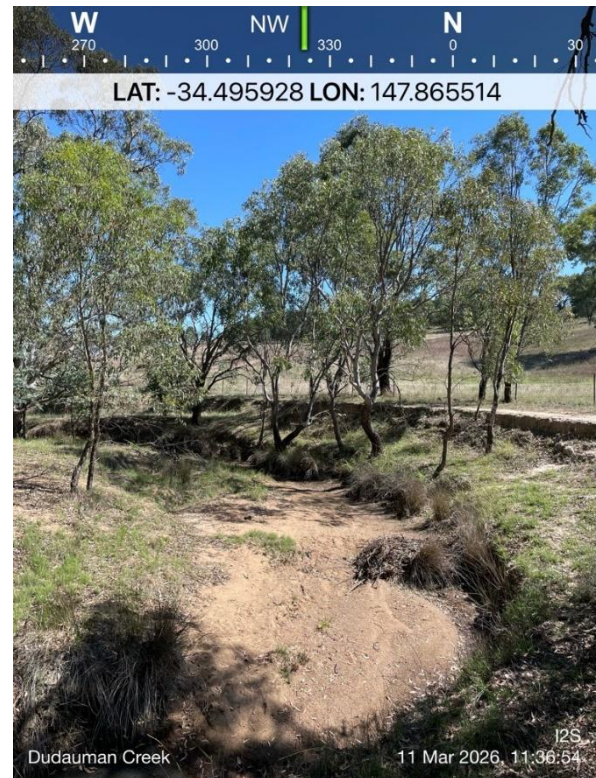
Figure B-22 Downstream and upstream (respectively) at Dudauman Creek – March 2026

Dudauman Creek is a 3<sup>rd</sup> order ephemeral watercourse within the Lachlan River catchment and is intersected by the Project at two locations in the vicinity of Stockinbingal. Dudauman Creek intersects the Project alignment in construction section 6 at CH37950, generally flowing from south to north before turning east through the township and ultimately joining Bland Creek downstream. Access to the watercourse and surrounding land has been limited for portions of the reporting period due to land access constraints. Aerial drone imagery has been used to capture upstream and downstream creek conditions, where possible.

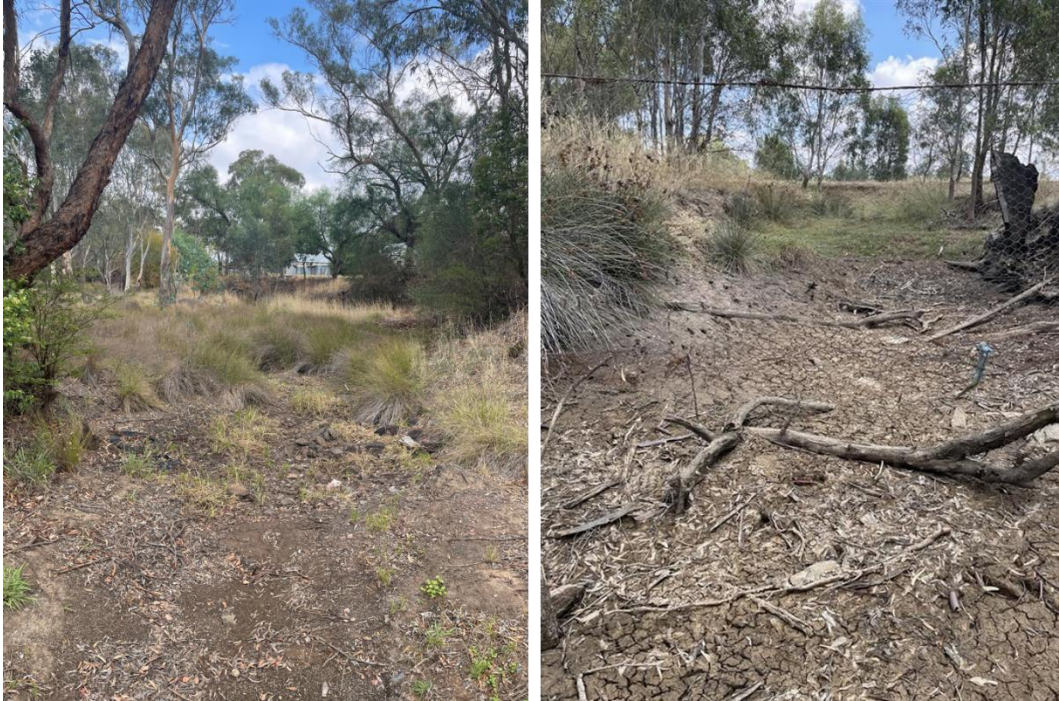
**B-25 Bland Creek - February 2026**

Bland Creek is located outside the Project boundaries in Stockinbingal. The creek generally flows from south to north and receives flows from Dudauman Creek and Powder Horn Creek downstream of the Project area. Bland Creek is not directly intersected by the Project and has been included as a reference monitoring site to assist in identifying broader catchment conditions independent of Project activities. During the reporting period, monitoring inspections recorded dry channel conditions.

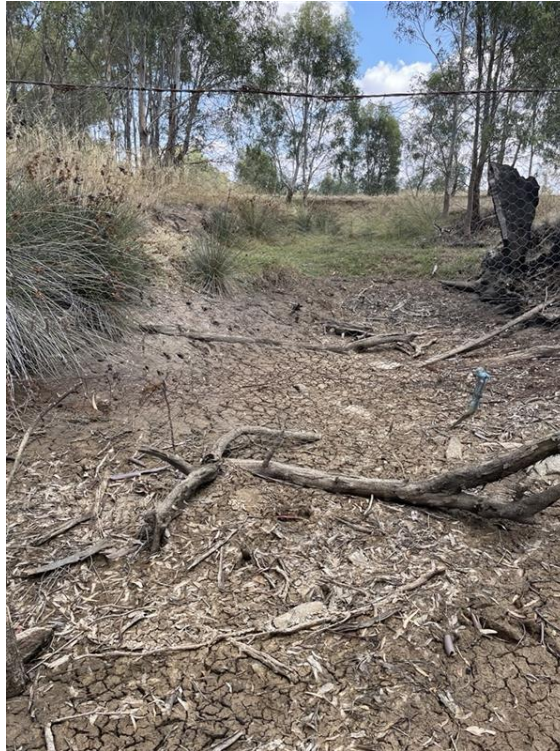
Figure B-28 Ironbong Creek - February 2026

Ironbong Creek is located outside of the Project boundary. Ironbong Creek is a 3<sup>rd</sup> order ephemeral watercourse within the Murrumbidgee River catchment located approximately 250m west of the Project corridor at its closest point. The creek generally flows in a north-south direction before joining Billabong Creek downstream. Ironbong Creek is not directly intersected by the Project and has been included as a reference monitoring site to provide a comparison against waterways potentially influenced by construction activities. During the reporting period, monitoring inspections generally recorded dry channel conditions, consistent with the ephemeral nature of waterways within the Project area. Ponded water was observed in Ironbong Creek on occasion however no flows were observed through the creek in the monitoring period.
