**INLAND RAIL – NARRABRI TO NORTH STAR PHASE 1:
FIVE-CLAWED WORM SKINK (*Anomalopus mackayi*)
CONSTRUCTION SPECIES MANAGEMENT PLAN (Rev 6)**

August 2024

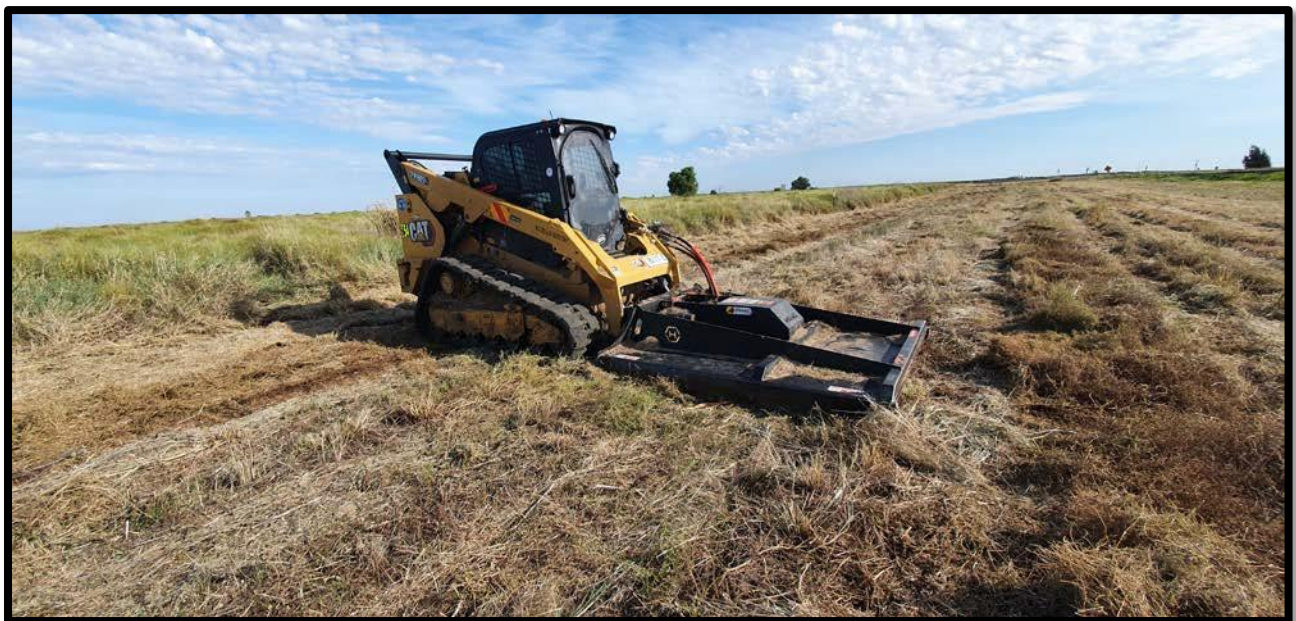
Plate 5-2. Slashing on vegetation prior to stripping in Stage 1.

- An ecologist or spotter-catcher to perform clearing supervision when the slasher is mowing vegetation. The slasher should be set at a cutting height that is near to the ground (<100 mm) in order to reduce the suitability of the retained habitat. The ecologist/spotter-catcher would turn suitable materials such as logs, disused sleepers, refuse whilst looking for dispersing skinks. Skinks captured during this stage would need to be retained until such a time the slashing has been completed adjacent to the relocation site noting that a series of measurements and habitat information is to be recorded (see Section 5.2.4).

- Slashed vegetation should be wind rowed to the edge of the ClZ to provide temporal refuge sites. This should be performed in a way so as to reduce the suitability of the habitat for FCWS within the ClZ. Ideally, slashing should seek to windrow the slashing material with each up and down pass so that it concentrates the windrowed material to enable more efficient FCWS checks prior to soil disturbance works.

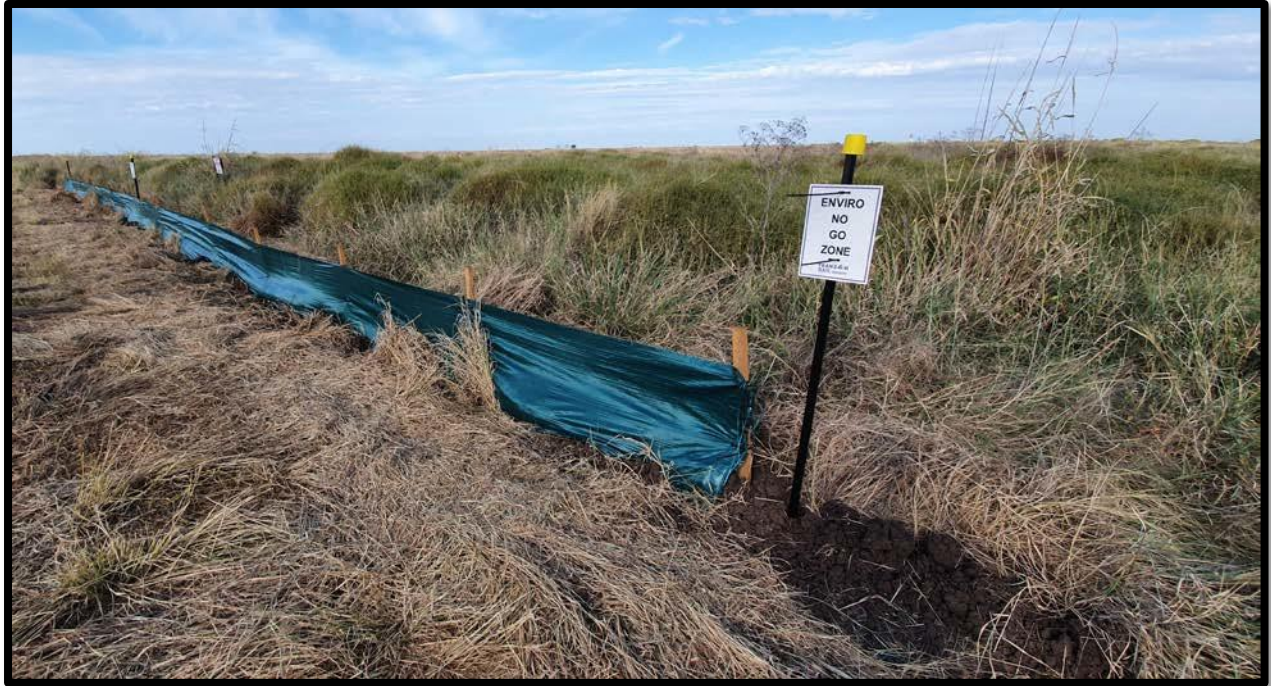
Plate 5-3. Example of a FCWS relocation hub installed in Stage 1 supported by environmental signage.

- Relocation sites should be established based on the capture sites. Silt fence is proposed to assist in delineating these areas and to reduce habitat permeability between the relocation site and the ClZ (Plate 5-3).
- Once the above works are completed within a given area, a minimum waiting period of 2 days/nights and up to 5 days/nights is proposed before topsoil stripping can commence. This adopted period should enable sufficient time for uncaptured FCWS to move of their own accord and be determined in consultation with Project Ecologist. The Project Ecologist should consider site-specific conditions at the time of clearing including the outcomes of any pre-clearing surveys, soil conditions (presence of moisture / cracking / baking), daytime temperatures and other factors that in the opinion of the Project Ecologist may or may not contribute to hostile ground conditions for the FCWS.

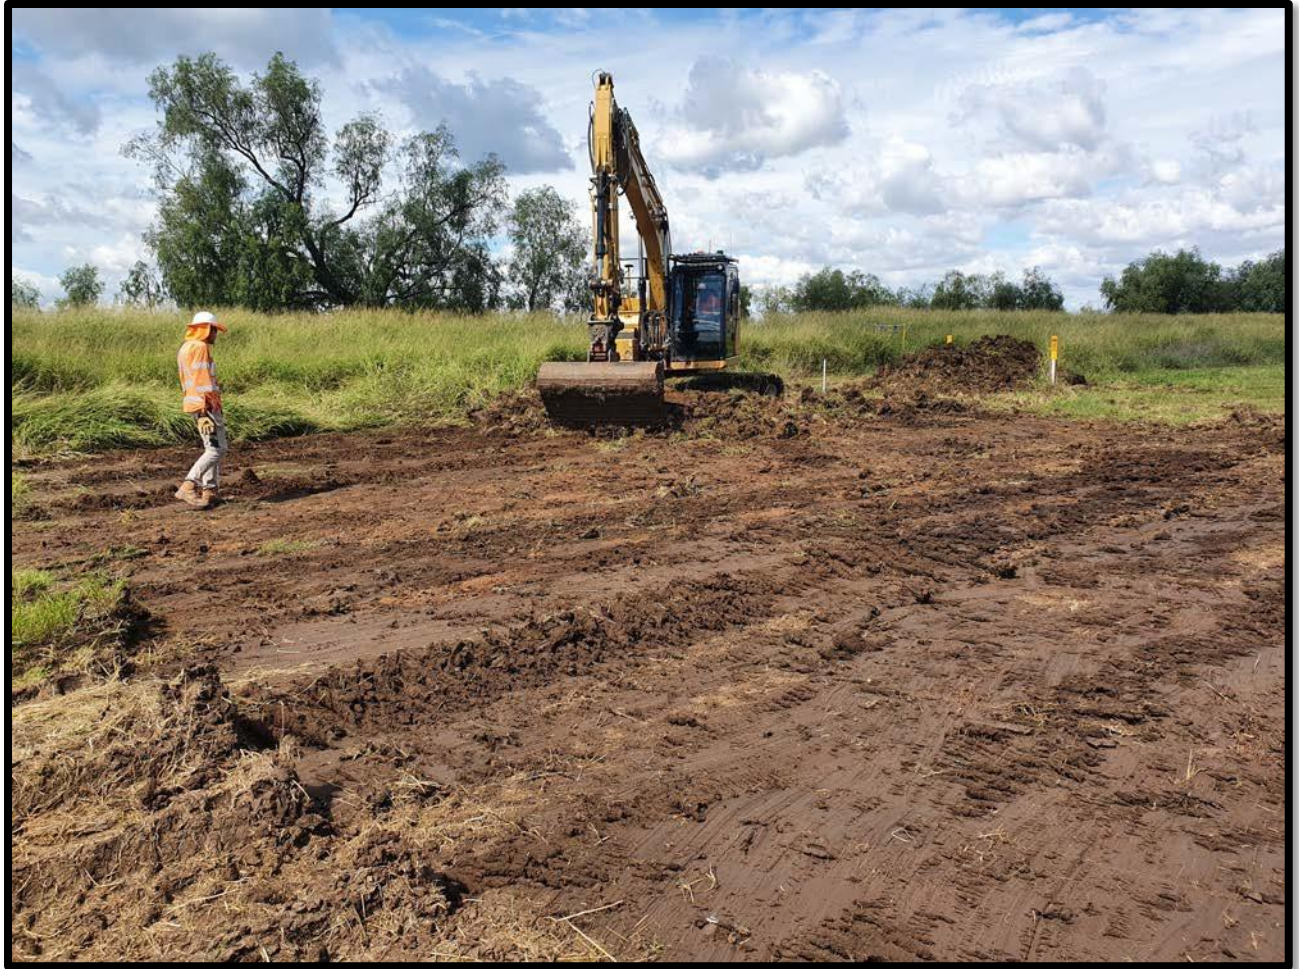
Plate 5-4. Example of top soil stripping to 100 mm depth at 599.02 in Stage 1.

- Topsoil stripping surveys to a depth of 100 mm would then be performed to capture and relocate displaced FCWS (Plate 5-4). At least one ecologist or spotter catcher will be assigned per machine (i.e. excavator, dozer, grader or scrapper). Should a scrapper be used, an ecologist or spotter catcher will be present to inspect the material at the recipient site.

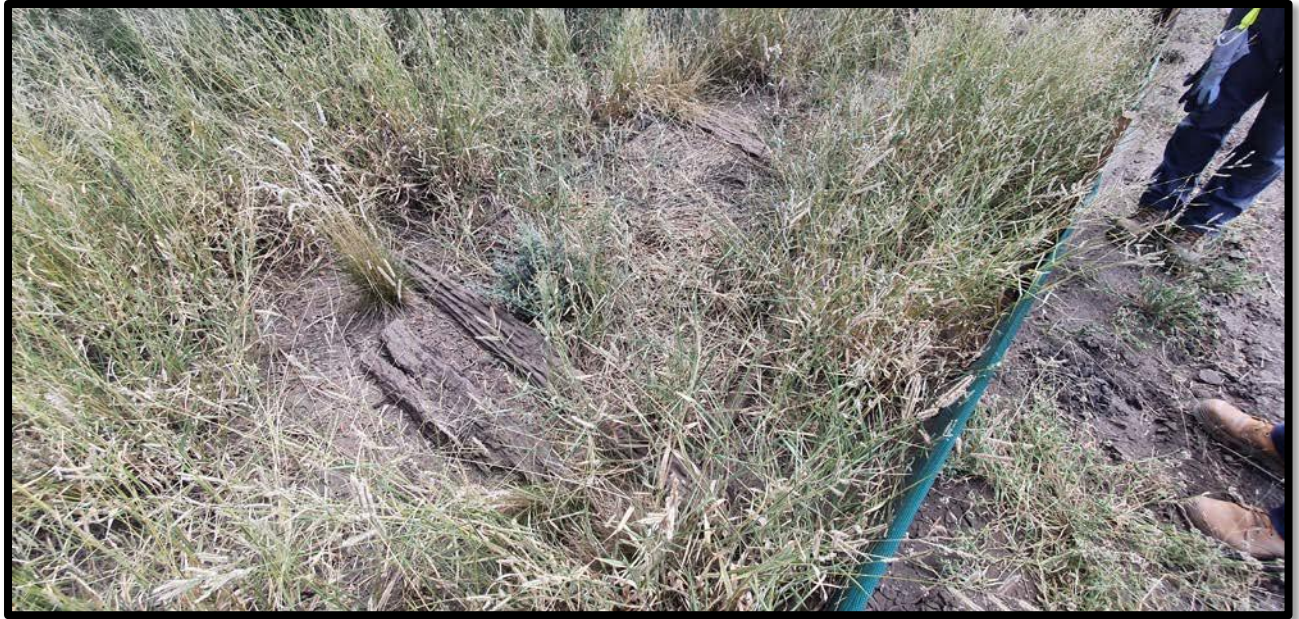
Plate 5-5. Temporary habitat enhancement works in Stage 3 using timber and hay biscuits to increase ground cover for relocated FCWS.

Phase 1 temporary habitat enhancement includes the placement of hay bales at 100 m intervals on land within the construction boundary.

More permanent habitat enhancement in Phase 2 will include the placement of coarse woody debris (e.g. logs, sleepers, or mulched woody vegetation piles) within the construction boundary. Where available, woody debris will be placed in a manner that is reflective of the pre-construction landscape. As an example, at Yallaroi Creek (CH740.59), woody debris were placed at an average rate of one piece per 10m², whereas in open areas where no vegetation was removed, no woody debris were placed.

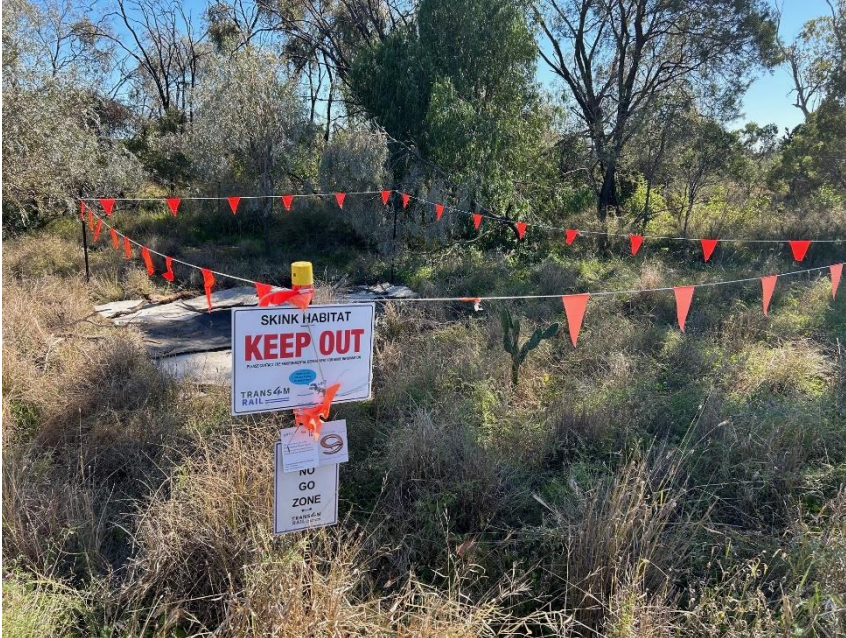
Plate 6-1. Treatment Type A (10A) where relocation hub within area immediately adjacent to the disturbance zone.

- **Treatment Type A – Relocation Hub.** This type of monitoring site is typically at the edge of the disturbance work zone and contains intact vegetation, received a range of construction related management actions including but not limited to being at or close to a relocation hub that received captured skinks, had habitat augmentation installed in the form of hay bales, timber and a skink protection fence constructed (Plate 6-1).

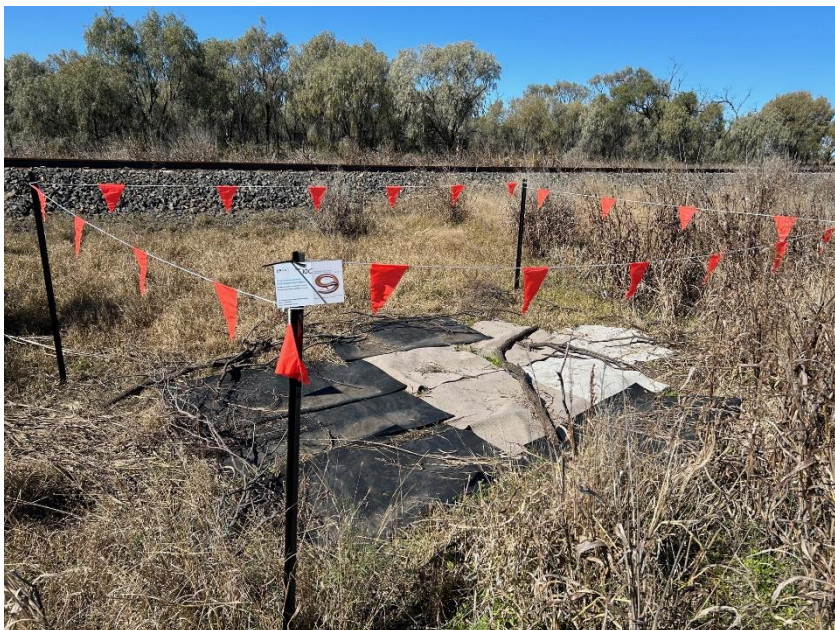
Plate 6-2. Treatment Type C (10C) where disturbance works removed vegetation and disturbed soil during construction.

- **Treatment Type C (Impact) – Disturbance Zone.** This type of monitoring site was heavily disturbed as part of the project with vegetation being cleared and grubbed and the soils either being excavated, trafficked or compacted. Typically, these sites are located within 10 m of the rail line and

feature disturbed soils and low growing plants such as grasses (Plate 6-2). They are often located within 100-200 m of the relocation hubs, rarely closer (i.e. Site 11A & C). This treatment type has been included into the program at the request of BCS given the department wanted to understand if FCWS would recolonize these areas post construction. They are considered an impact site.

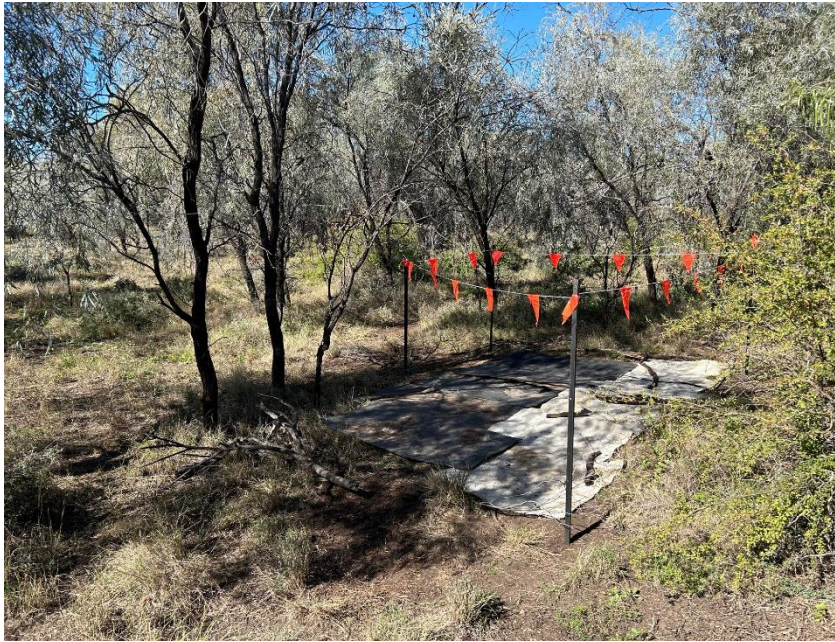
Plate 6-3. Treatment Type B (Site 10B) where sites were established in adjacent habitat of the same plant community type.

- **Treatment Type B – Reference.** This type of monitoring site has been located at least 200 m away and at times a number of kilometres from the impact site but within the same PCT and local area (Plate 6-3). As these sites were unaffected by the

project they are considered control or reference sites and are used to measure external factors such as seasonality (i.e. drought/flood) and assist with other abiotic cues (i.e. air temperatures, rainfall).

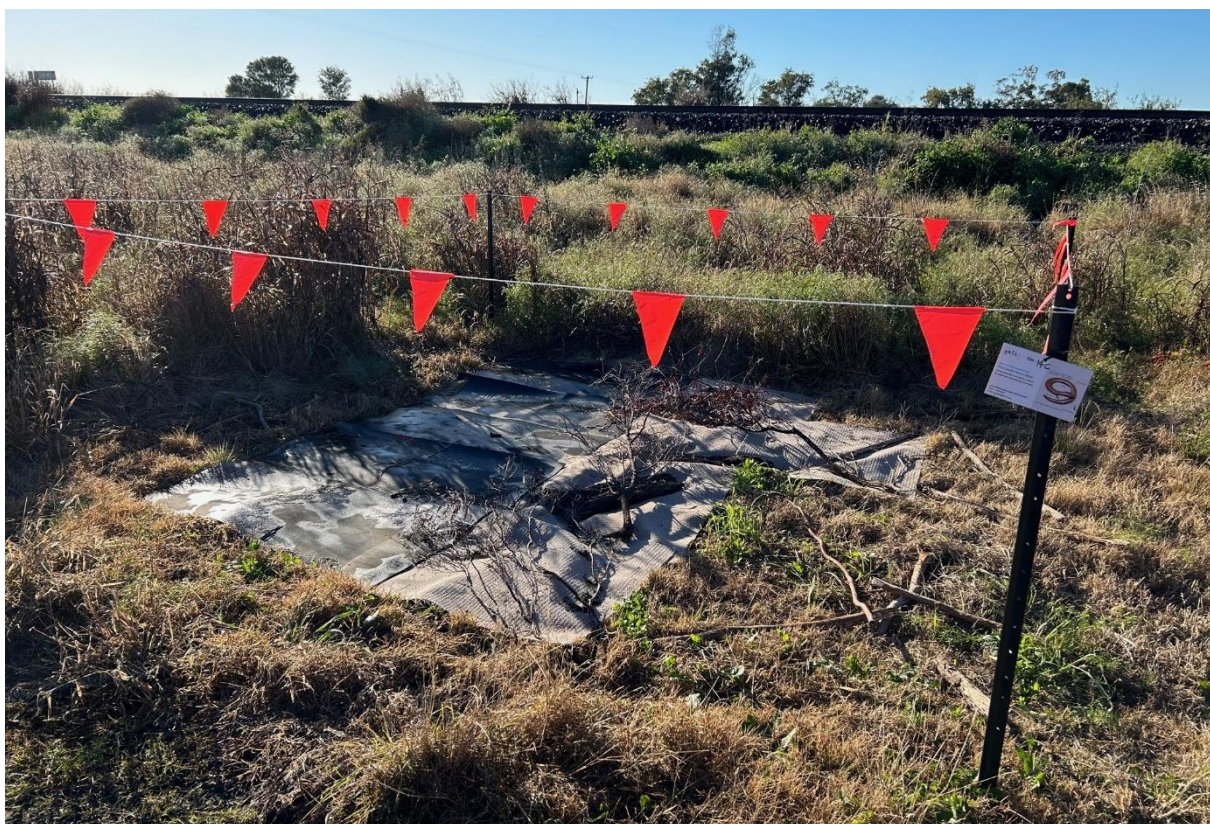
Figure 6-3. Artificial shelter site configuration using the clumped configuration as directed by DCCEEW NSW.

The current configuration or arrangement of rubber and carpet tiles is the result of directive from BCS DCCEEW – NSW in 2024, that being to clump the carpet and rubber tiles together in an overlapping nature to create a single continuous covering. (Figure 6-1).

Artificial refuge sites should be installed 12 weeks ahead of scheduled monitoring. Monitoring will generally be performed in early autumn (i.e. March-May) and late spring (i.e. mid September-November), however may be carried outside of these periods where favourable seasonal conditions permit. This time period has been selected to compensate for the variability in ambient temperature whilst accounting for periods of rainfall based on the long-term climatic averages for Moree (BoM 2022). Surveying at this time of the year should also alleviate concerns associated with excessive heat (>35 degrees Celsius) or it being too cold (<20 degrees Celsius), thereby increasing the likelihood of detection. In determining appropriate survey periods, consideration will also be given to factors such as preceding rainfall conditions and soil moisture levels. Soil moisture content is considered a key trigger for monitoring events.
